Manhole Inspection Summary

Manhole # S13W__012MH

Insp Date: **1/9/09 2:05 PM**

Location Address: **Wilmarco Dr.**

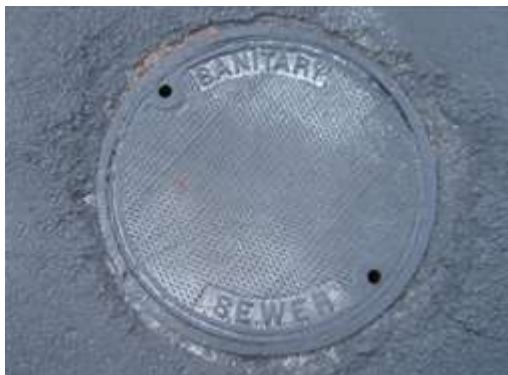
MH Lid

Cover Shape: **Circular** Diameter: **26** (in.) Length: **0** (in.) Dist A/B Grade: **0** (in.)

Condition: **Sound**

Cover Material: **Cast Iron**

☒ **Leaks**

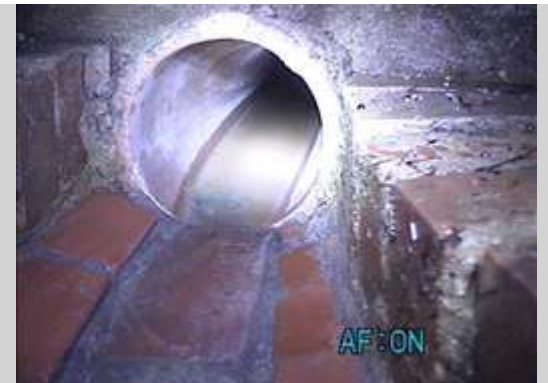
7 O'Clock Inflow

6 in. Circular Gravity Sewer
Pipe In @ 7 O'Clock

Pipe Height: **6** (in.) Rod and Bar (Angled)
Pipe Material: **Clay** ☐ Pipe Lined
Invert Depth: **9.38** (ft.) Flow Characteristics: **Slow**
Deposits: ☒ None ☐ Mud ☐ Sludge ☐ Debris ☐ Grease
Silt Depth: **0** (in.) Deposits Extent:
Infiltration: **None** Pipe Seal Cond: **Sound**
